Manhole Inspection Summary

Manhole # S69W__008MH

Location Address: **1820 Portal St.**

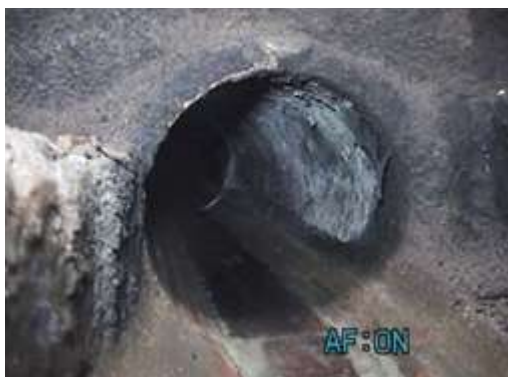
Defect 3

pipe seal crack 9oclock

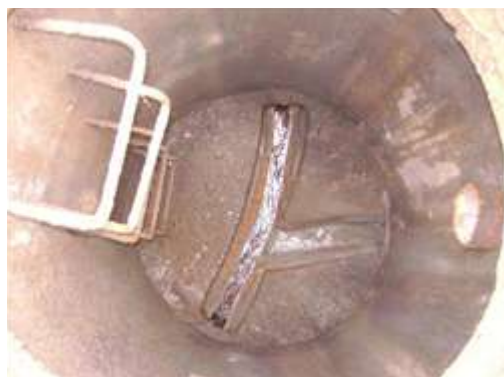
Defect 1

Condition: ☐ Sound ☐ Cracked ☐ Root Intrusion ☐ Loose Brick ☒ **Deteriorated**

Infiltration: ☐ None ☒ **Joint** ☐ Cracks ☒ **Mortar** ☐ Roots ☐ Wall

Infiltration: ☐ None ☒ **Joint** ☐ Cracks ☐ Mortar ☐ Roots ☐ Wall

infiltration of corbel, barrel, and chimney

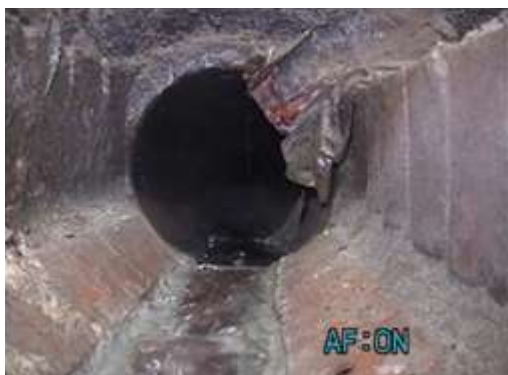
Defect 2

Debris settled against wall and bench blocking 12oclock outgoing pipe from the 12 to the 3.

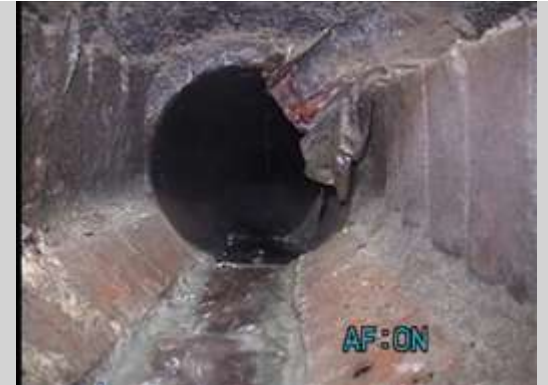
12 O'Clock Outflow

Pipe Height: **8.4** (in.) Rod and Bar (Angled)
Pipe Material: **Clay** ☐ Pipe Lined
Invert Depth: **8.25** (ft.) Flow Characteristics: **Fast**
Deposits: ☒ None ☐ Mud ☐ Sludge ☐ Debris ☐ Grease
Silt Depth: (in.) Deposits Extent:
Infiltration: **None** Pipe Seal Cond: **Sound**

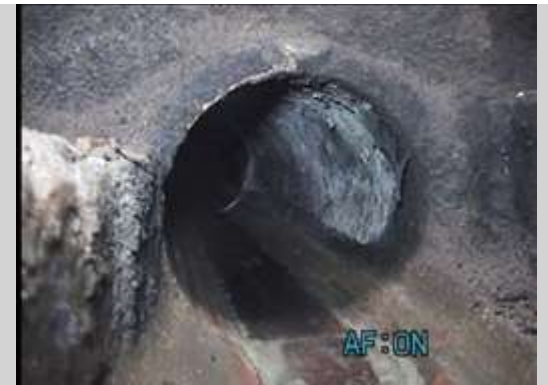
6 O'Clock Inflow

Pipe Height: **8.4** (in.) Rod and Bar (Angled)
Pipe Material: **Clay** ☐ Pipe Lined
Invert Depth: **8.08** (ft.) Flow Characteristics: **Fast**
Deposits: ☒ None ☐ Mud ☐ Sludge ☐ Debris ☐ Grease
Silt Depth: (in.) Deposits Extent:
Infiltration: **None** Pipe Seal Cond: **Sound**

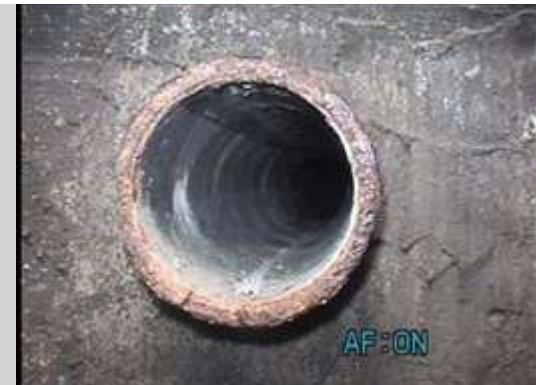
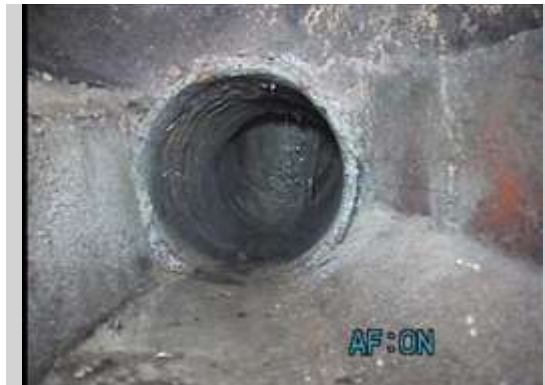
9 O'Clock Inflow

Infiltration: **None** Pipe Seal Cond: **Sound**

Drop: **Outside** Rod and Bar

Drop Condition: **Open**
